4. A PROBLEM OF OVERABUNDANCE

LAKE WINONA WATERSHED

PREPARED BY WINONA STATE UNIVERSITY

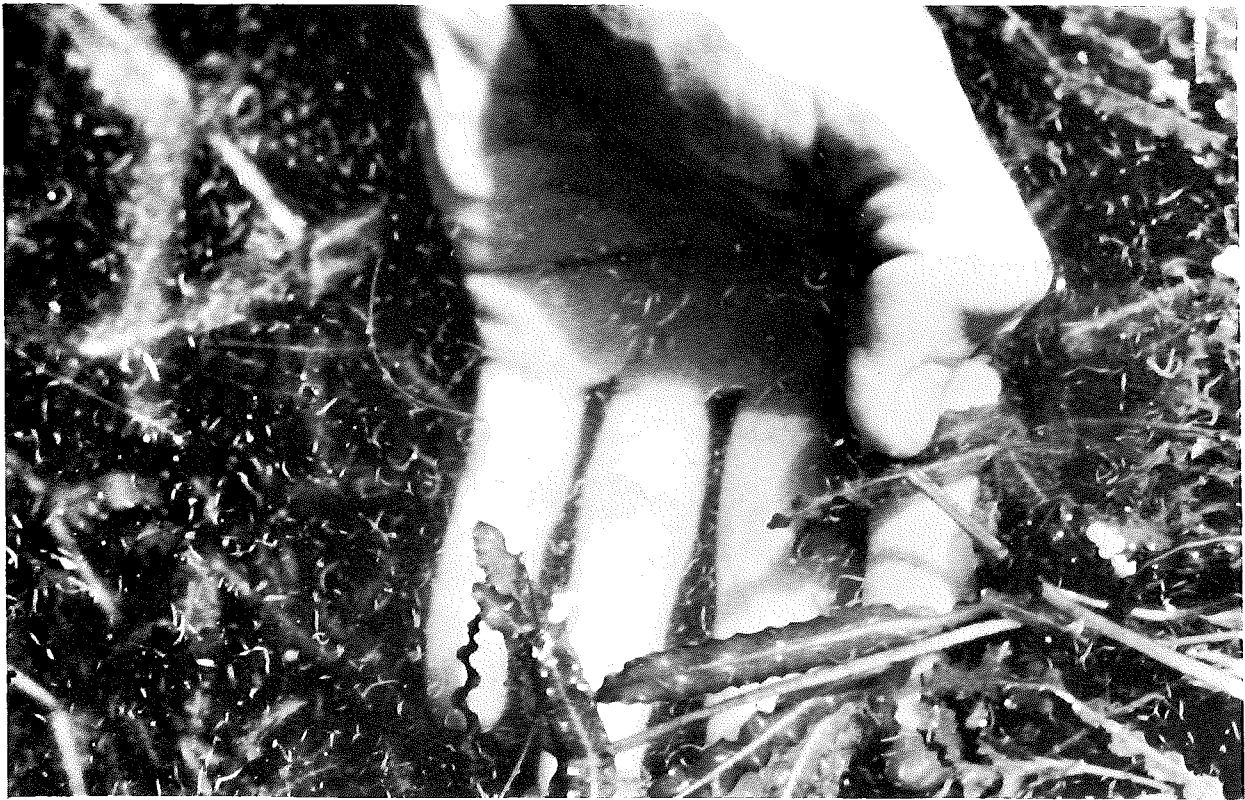
Fig. 4-2 The growth of blue-green algae and rooted aquatic plants is stimulated by fertilizer elements.

Because Lake Winona is so rich in fertilizers, it can be correctly termed a eutrophic (enriched) lake. In past years, like other eutrophic lakes, it often became "peasoup" green with algae in the summer (Fig. 4-2). The large algae populations in the lake provided food for dense populations of microscopic invertebrate animals which in turn served as food for unusually large populations of fish. At the time that the rehabilitation program was initiated in 1973, Lake Winona contained over 730 pounds of fish per acre. By comparison, the crystal clear, relatively infertile waters of a Canadian trout lake would probably contain as little as 40 pounds of fish per acre.

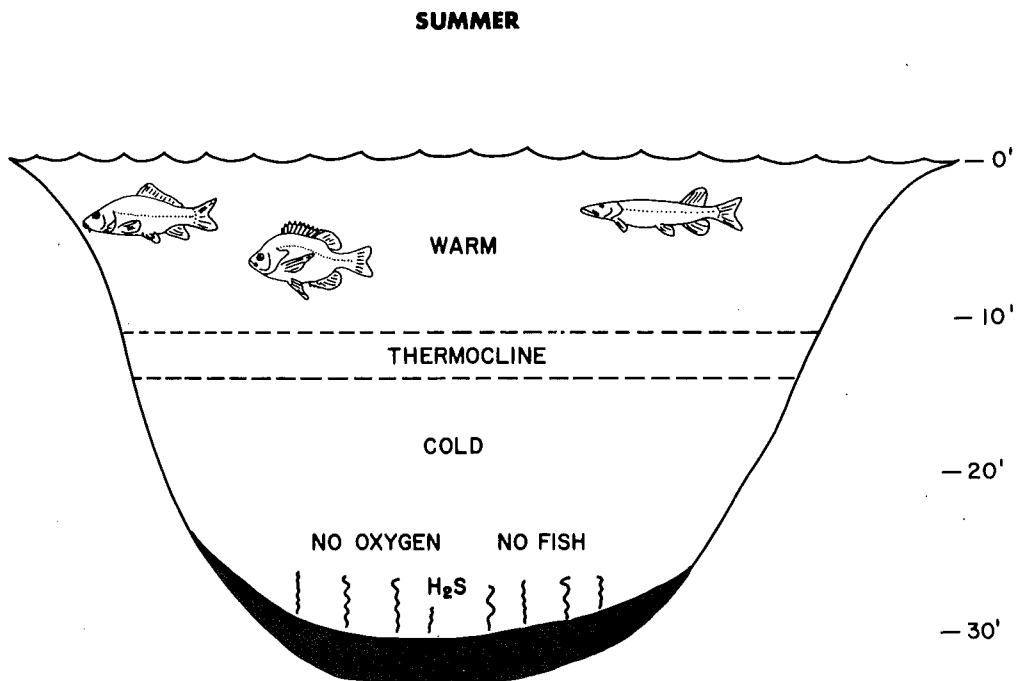
Fig. 4-3 If not artificially aerated, Lake Winona thermally stratifies during the summer. This is a natural process and it occurs in most lakes.

Eutrophic lakes, such as Lake Winona, typically stratify (become layered) during the summer (Fig. 4-3). As the lake warms, the warm water floats on top of the colder, denser water beneath. During late summer the warm water layer, which is fairly uniform in temperature, is usually about 12 feet deep. If not artificially destratified by aeration, Lake Winona is two lakes during the summer - one warm (the epilimnion), the other cold (the hypolimnion). A third layer (the thermocline) lies between the epilimnion and the hypolimnion and is a zone of rapid temperature change. The uniformly cold hypolimnion is thus completely isolated from the epilimnion and from the atmosphere. Consequently, it receives no oxygen from the atmosphere by wave action; and it usually receives no oxygen via photosynthesis because little sunlight penetrates the algae-rich water above. The hypolimnion tends to be devoid of oxygen in late summer because its abundant organic load, living and dead, consumes so much oxygen.

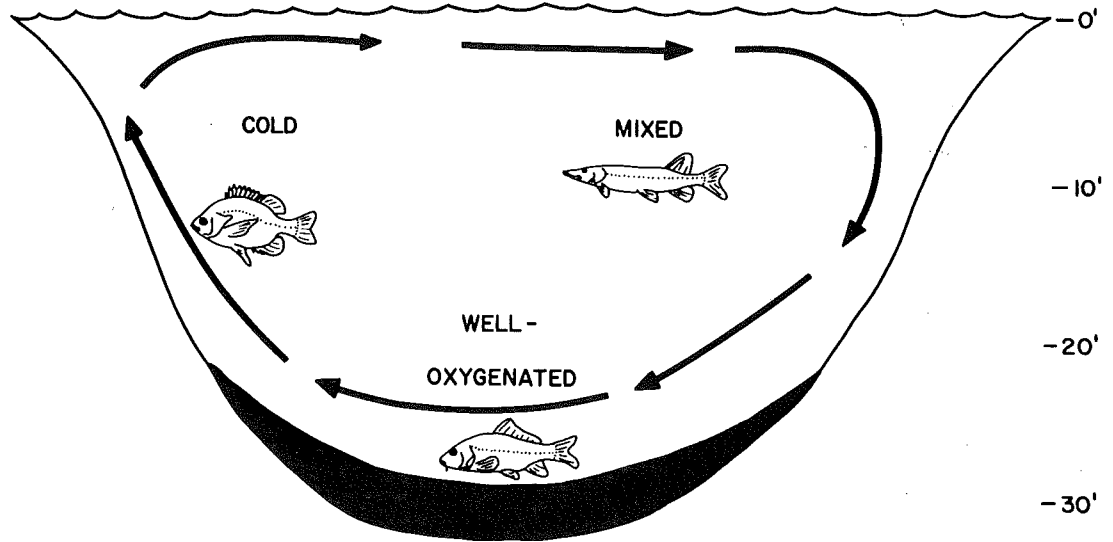
SPRING AND FALL

Fig. 4-4 During spring and fall, Lake Winona is not thermally stratified and it is mixed and aerated by the wind.

In the spring and fall, the depths of a eutrophic lake "take a breath" when the lake becomes uniform in temperature from top to bottom and the wind is able to mix the lake thoroughly (Fig. 4-4). During these times of ventilation, the musty smells of anaerobic decomposition can be noticed downwind from a highly eutrophic lake. This was very evident downwind from Lake Winona prior to reclamation.
