14. BOLLER LAKE: A VITAL LINK IN THE MANAGEMENT OF LAKE WINONA

NORTHERN PIKE CAPTURE AT BOLLER LAKE, WINONA, MINNESOTA

ANNUAL REPORT
NORTHERN PIKE CAPTURE AT BOLLER LAKE, WINONA, MINNESOTA
DURING THE WINTER OF 1982-83

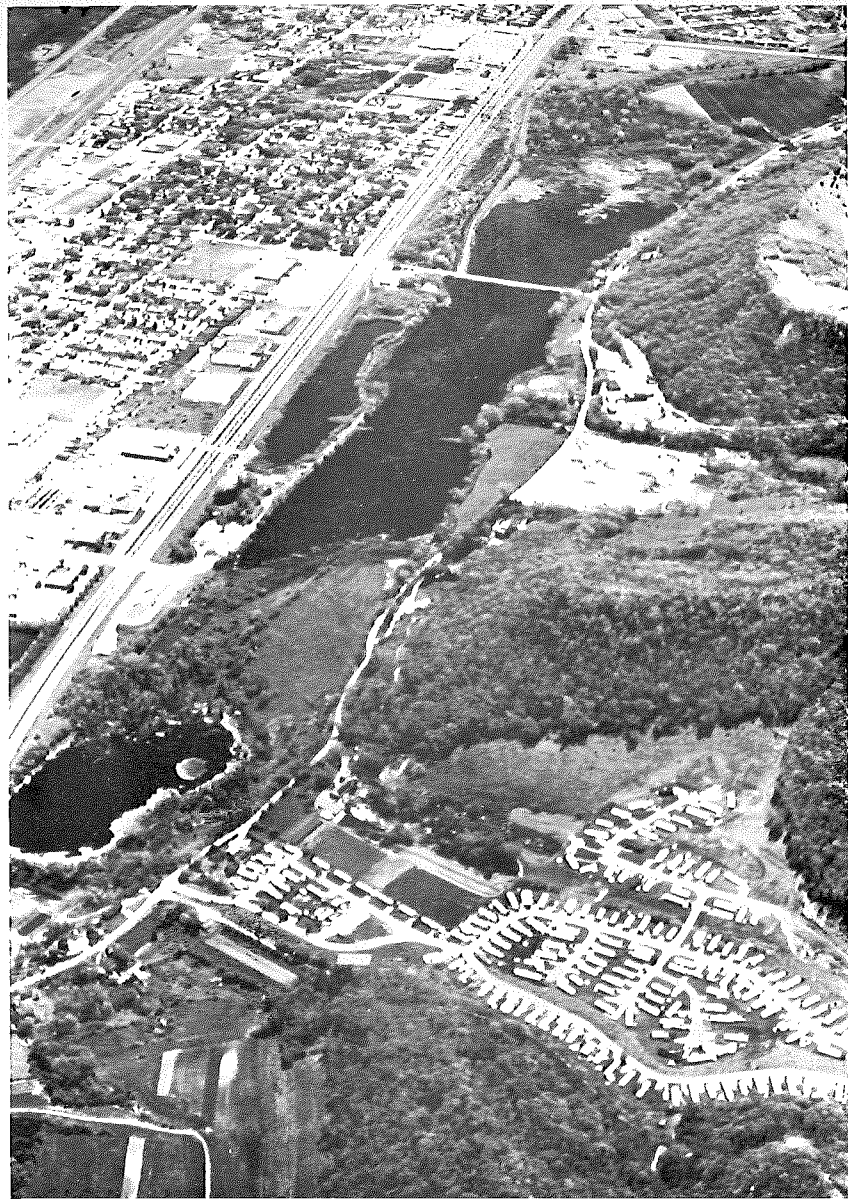
Figure 14-1. Boller Lake. The City of Winona and Biesanz Stone Quarry lie in the upper right, the City of Goodview in the upper left, and Hidden Valley Trailer Court in the lower right

Boller Lake lies between Highway 61 and the Winona bluff line, bounded by Winona and Minnesota City (Fig. 14-1,2). The lake is not within the city limits of Winona, Minnesota City or Goodview, however, but is within the jurisdiction of Winona Township. The City of Winona has had flood easements on Boller Lake since 1944, and is thus entitled to control the water levels of Boller Lake. The history of Boller Lake up to 1973 is outlined in Chapter 3.

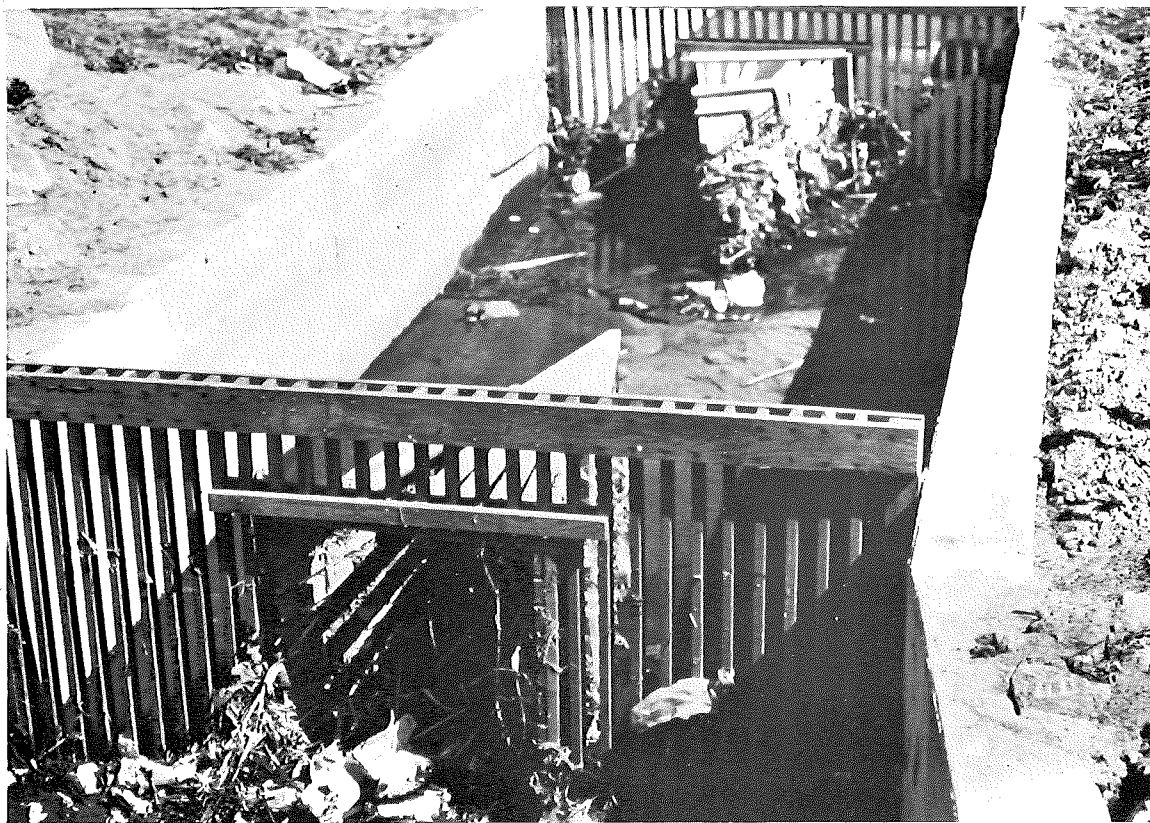
Figure 14-3. Carp trap constructed in County Ditch No. 3 at Junction Street. The trap proved ineffective because debris from storm sewers plugged it continually.

A malfunctioning electric weir allowed carp and other fish to gain entrance to Boller Lake in the spring of 1974. It was obvious that if not controlled, the carp produced in Boller Lake could overwhelm Lake Winona. Carp traps were employed in County Ditch No. 3, but it soon became obvious that they were not very effective (Fig. 14-3). Consequently, it was deemed necessary to develop an inexpensive method of killing all fish in Boller Lake whenever the lake became infested with undesirable species. Rotenone treatment of Boller Lake would have sufficed, but would have been prohibitively expensive. (The Ziebart Sand Pit which is connected to Boller Lake had to be treated with rotenone on October 25, 1976. It yielded about 1000 carp and about 60 northern pike).

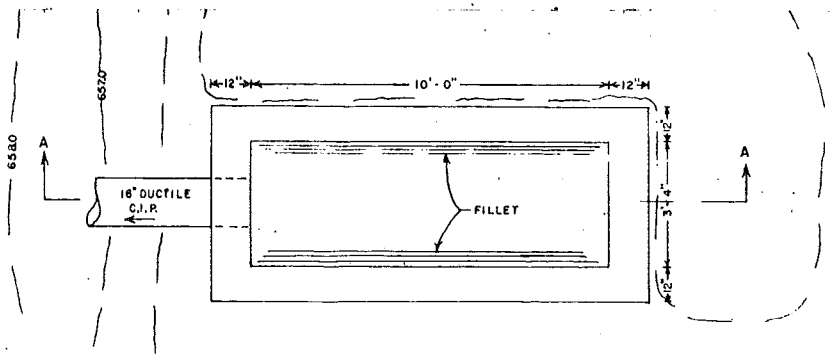
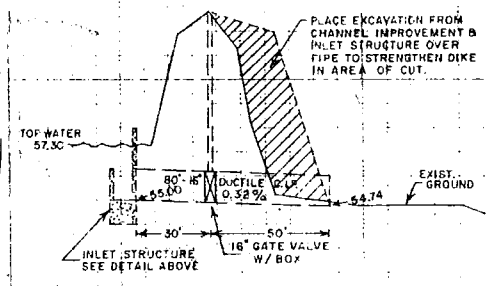
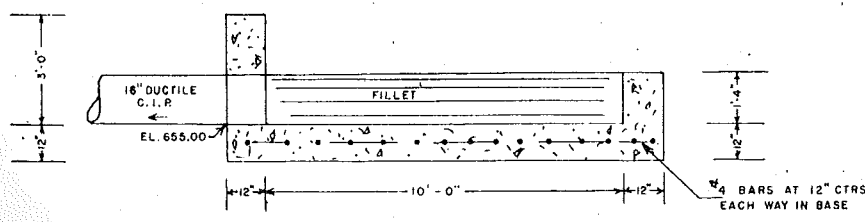
GILMORE CREEK INLET STRUCTURE

PLAN VIEW

INLET STRUCTURE

SECT. A-A

Figure 14-4. By-pass constructed in 1975 to divert Gilmore Creek around Boller Lake at will, thus making it possible to control rough fish via a winterkill.

In the fall of 1975, a by-pass was installed which could divert Gilmore Creek directly into County Ditch No. 3 (Fig. 14-4). The by-pass has not functioned as well as expected because: 1) the culvert is not large enough to accomodate Gilmore Creek, 2) it is easily sabotaged by vandals who can plug the culvert from either end, 3) the gate valve is difficult to operate and is presently unworkable because the gears are stripped. To prevent vandalism, a heavy padlocked iron grating has been installed at the inlet to the culvert.

The greatest problems, however, were with the by-pass itself. It simply would not accept all of Gilmore Creek's flow, thus allowing a trickle to enter Boller Lake, thus providing northern pike a sanctuary of oxygenated water. The gate valve malfunctioned frequently. Heroic efforts at building temporary dams and water diversions were frustrating and time consuming.

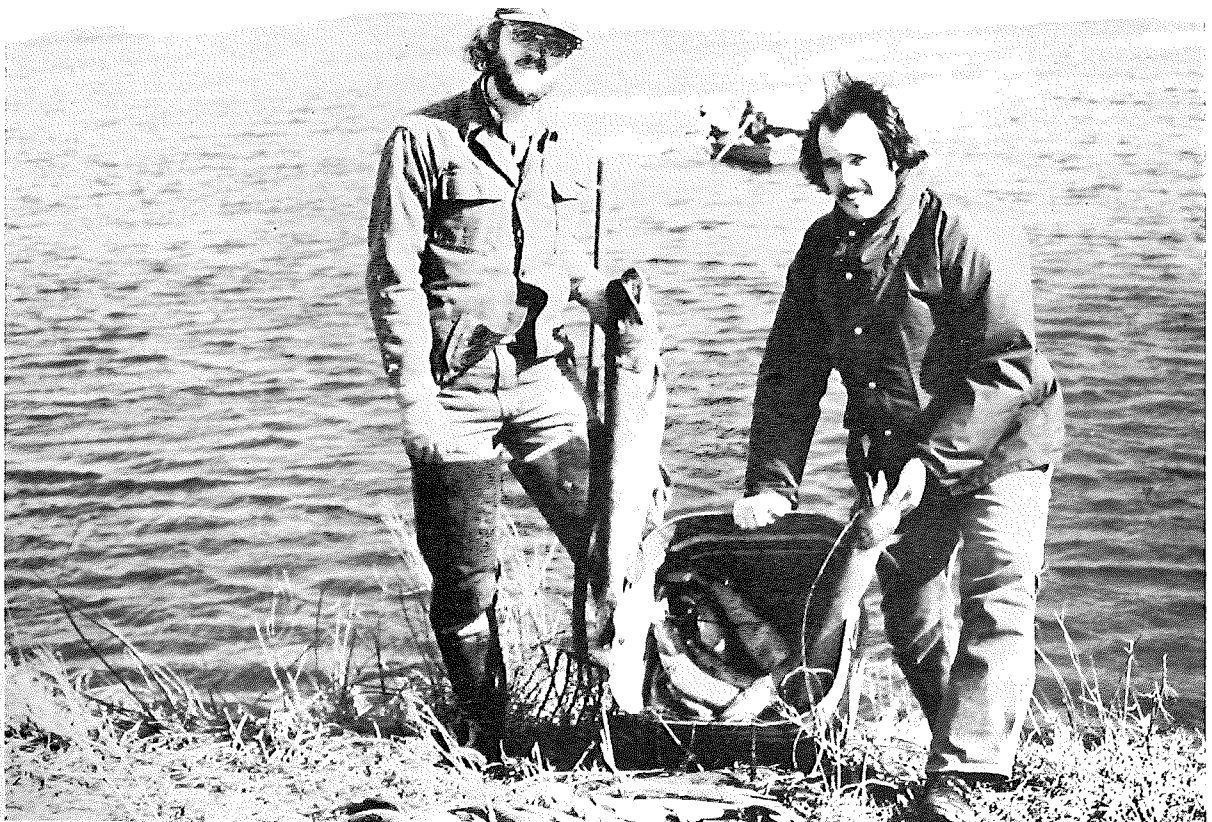
Figure 14-5. Dead fish collected from Boller Lake by WSU students after the spontaneous winterkill of 1976-1977. An estimated 2,864 pounds of northern pike were lost.

In the winter of 1976-1977, a spontaneous winter kill occurred in Boller Lake. In the fall, city crews had cut the brush from the diked portion of Gilmore Creek between St. Mary's College and Boller Lake as part of routine maintenance prescribed within the floodway. Because of extreme cold early in the winter and a lack of snow and protecting brush, a strong coat of ice developed on the creek. With the first snowfall, snowmobilers used the creek bed for a path, thus compacting the snow and reducing its insulation. As a result of subsequent extreme cold, anchor ice formed on the bottom of Gilmore Creek near its entrance to Boller Lake. Thus dammed, Gilmore Creek poured out over Boller Lake's ice cover, freezing as it did so. Because they were deprived of oxygenated water, Boller Lake fish suffocated during the winter of 1976-1977. Winona State University students assessed the kill the following spring (Fig. 14-5). Their data is summarized in Table 14-1.

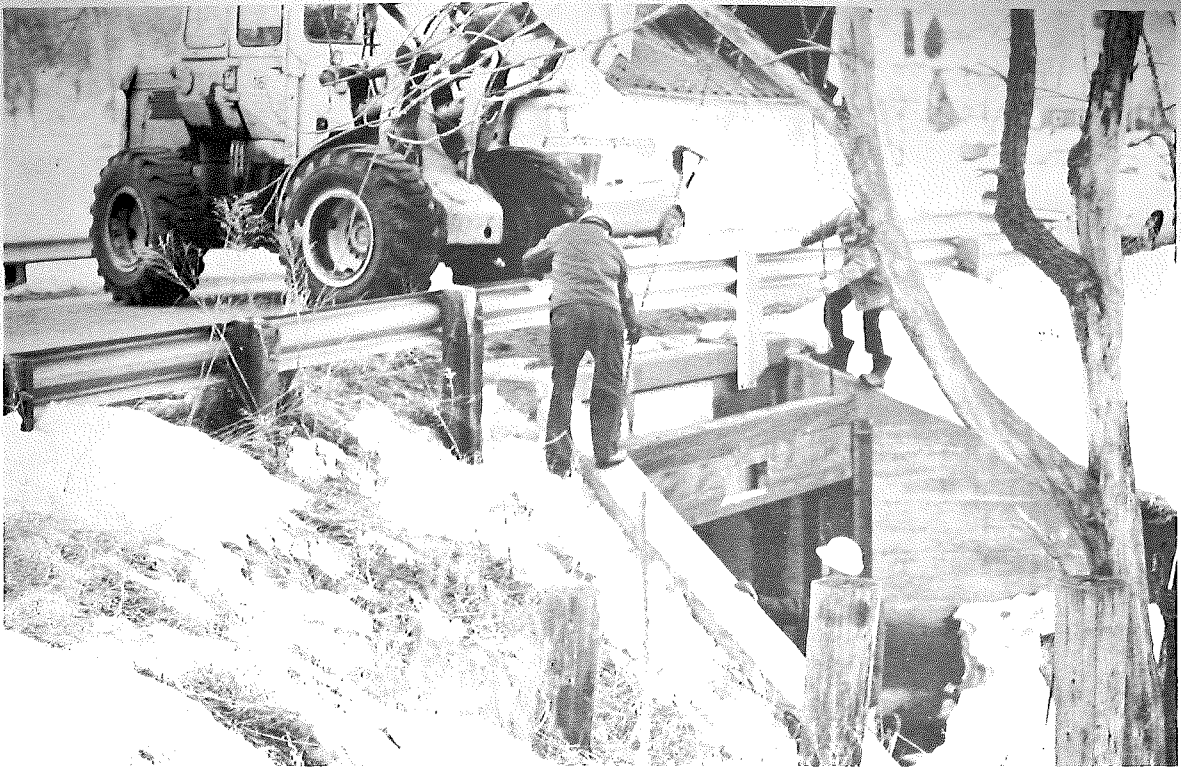
Fig. 14-6. Stop log gate being lowered into place at Boller Lake outlet dam. The rectangular hole in the bottom can be easily opened, thus allowing flow into a fish trap located in the culvert.

The Lake Winona Committee constructed a new gate for the Boller Lake outlet dam in 1979 (Fig. 14-6). The stop-log structure had a small rectangular hole in the bottom which could be easily closed by positioning a piece of plywood on the upstream side of the dam. Water pressure held the plywood closure in place.

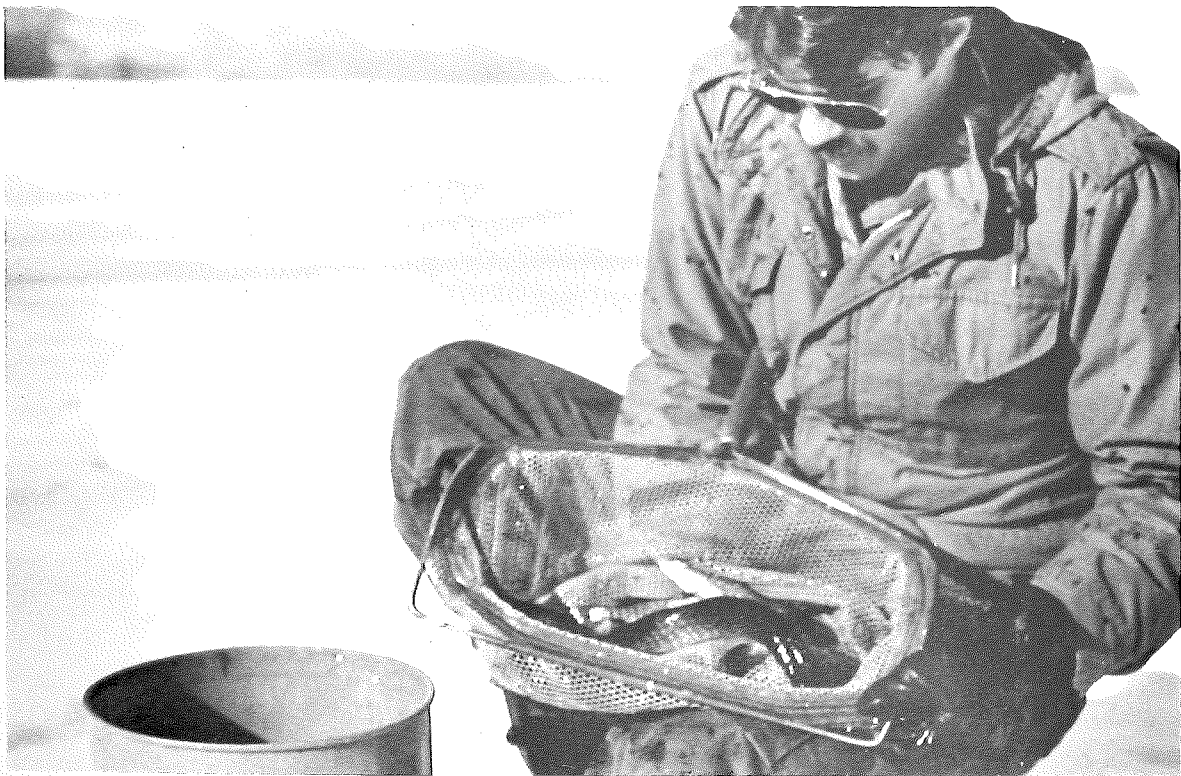
Fig. 14-7. Young-of-the-year northern pike captured at Boller Lake and stocked into Lake Winona

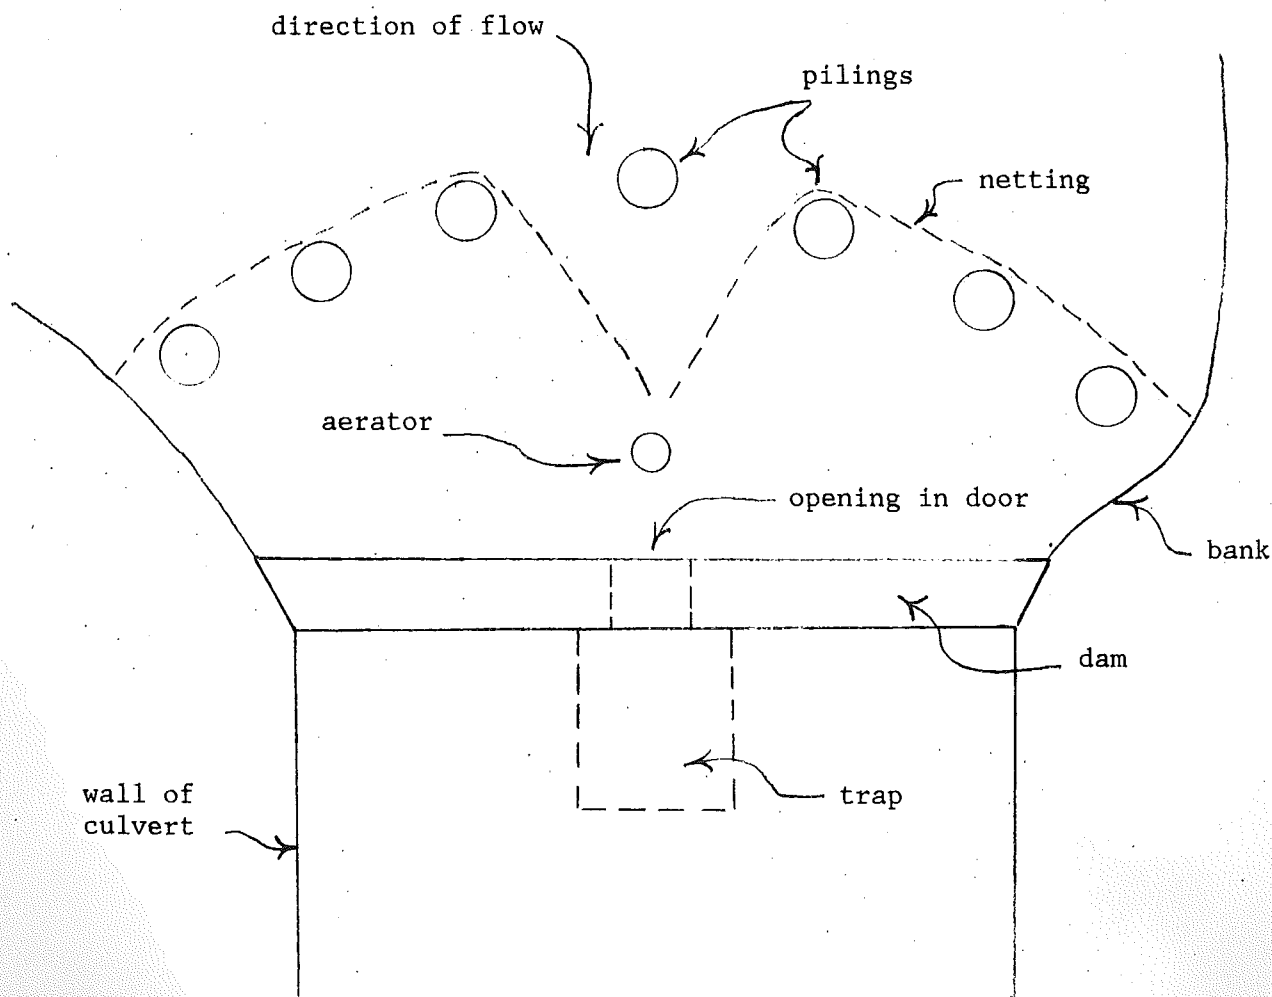
Prior to freeze-up, a new trapping system was installed at the Boller Lake dam (see diagram below). The trap which had been used in previous years was placed below the dam as usual, but a new net was constructed and placed around the pilings in Boller Lake to serve as a primary trap. An aerator installation was erected within the primary trap so that a 1/3 hp Minno-Saver agitator-type aerator could be mounted later. Electricity was provided by a line extended to the nearby Goodview Motor Mart. Tim Breza, owner of the Mart, made this possible and also paid several months of electricity. The Lake Winona Committee agreed to pay for the electricity for the remainder of the winter.

Water levels in Boller Lake were raised about one foot before freeze up in the fall. A water level gauge was erected above the Boller Lake dam and daily records were kept. In late December, after the ice cover was thick and there was a heavy covering of snow, the by-pass was opened to divert Gilmore Creek around Boller Lake, thus causing oxygen depletion and an impending winterkill. This operation also provided a flow of oxygen-rich water into Lake Winona. An aerator was installed just above the dam to attract northern pike. When oxygen levels throughout Boller Lake had dropped to less than 0.5 parts per million, the hole in the bottom of the dam was opened and water flowed into a trap constructed under the bridge at the Boller Lake outlet. Stressed northern pike followed the current into the trap, were netted out, and transported to Lake Winona (Fig. 14-7). A diagram of the trap is contained in the Annual Report for 1982-83, included at the end of this chapter.
